CUSTOMER SUCCESS STORY

WIRELESS MONITORING PREVENTS PRODUCTION LOSS

INDUSTRY | Automotive – Rubber

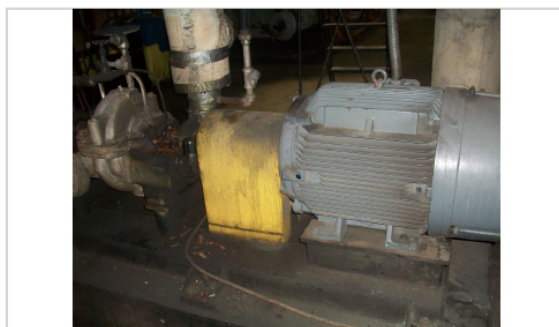
Asset Photo

Analysis Comment: The vibration data and cross channel phase analysis indicates misalignment at the coupling.

Failure Mode: Misalignment

Reason: Improper Alignment

1230-UTI-STM-WTR-BFP-P01-#1 BOILER FEED WATER PUMP

Repair Recommendation: Perform a precision alignment and replace the elastomer coupling insert. Align the key ways 180 degrees apart. Set the coupling gap to the manufactures recommended distance for the coupling being installed. Properly lubricate the coupling if applicable.

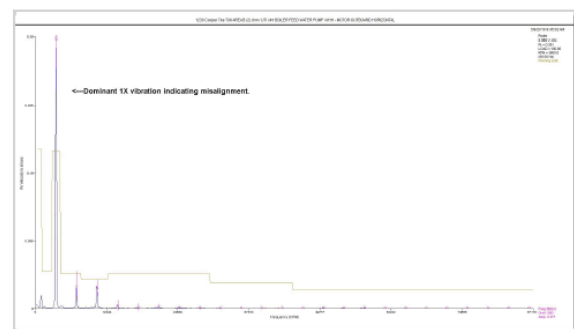
Vibration spectrum indicating misalignment.
