## CUSTOMER SUCCESS STORY

# CONTINUOUS MONITORING SAVES TIME AND MONEY

INDUSTRY | Chemical Processing

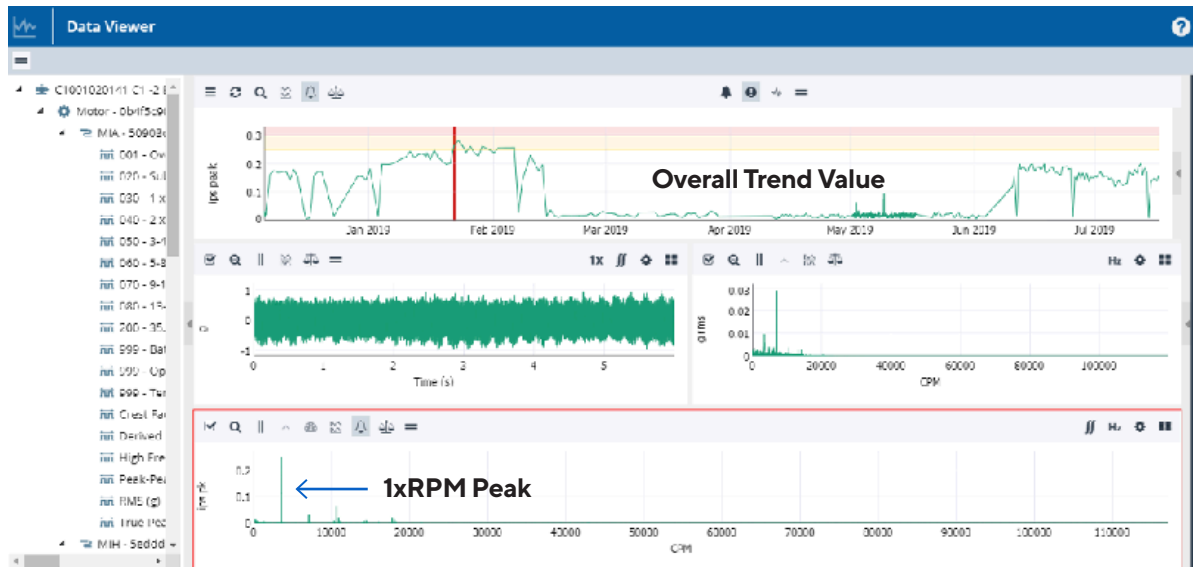
Our wireless system detected an increase in energy at 1xRPM and overall data that exceeded the alarm threshold thus sending an alarm to the Allied Analyst. The Allied Analyst then leveraged the SmartCBM™ reliability tool suite to determine the cause.

A full review of the data indicated that the coupling had locked up at startup. The analyst created a fault entry report for the customer and communicated to everyone that was impacted. The report clearly outlined the assessment and the repair recommendation. Further inspection revealed that product had clogged the entire baghouse and 'bridged' over 50% of the 'dumps', causing a turbulent flow issue. The facility was shutdown to complete the repair, which took less than 15 minutes.

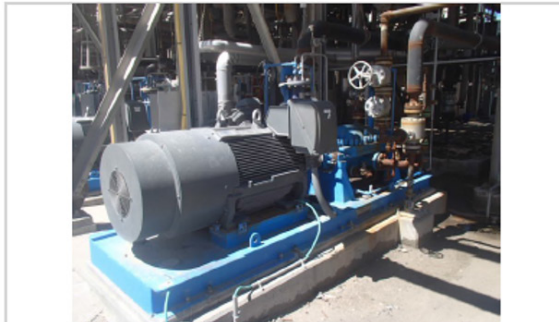
C1001020141 #2 Boiler Feed Water Pump (1-3)

- Analysis Comment:**
- Increasing vibration on motor at one times operational speed.
  - This signature is commonly associated with coupling misalignment and/or damage.

- Repair Recommendation:**
1. Ensure all mounting hardware is intact with proper torque.
  2. Inspect coupling for wear/damage and verify alignment is within 0.002".
  3. Complete any additional repairs as found.
  4. Contact Allied for a post repair quality check when repairs are complete.

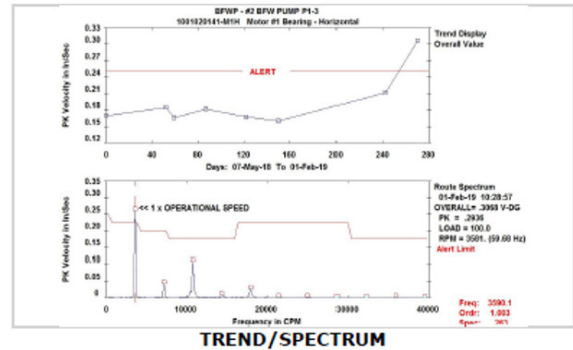
Fault entry report capturing analysis and repair recommendation for client
