CUSTOMER SUCCESS STORY

WIRELESS MONITORING PREVENTS PRODUCTION LOSS

INDUSTRY | Automotive – Rubber

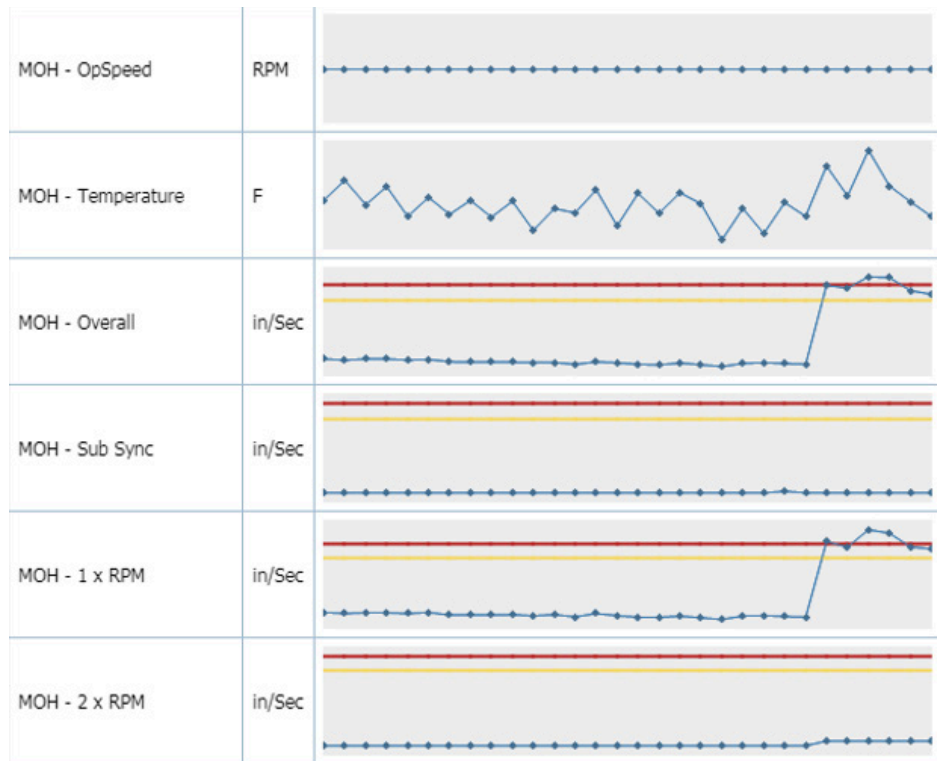
A full review of the data indicated that the coupling on a boiler feed water pump had locked upon startup. The analyst completed a fault entry report for the customer and communicated to everyone that was impacted. The report clearly outlined the assessment and the repair recommendation.

Analysis Comment: The vibration data and cross channel phase analysis indicates misalignment at the coupling.

Failure Mode: Misalignment

Reason: Improper Alignment

Fault entry report capturing analysis and repair recommendation for client

Repair Recommendation: Perform a precision alignment and replace the elastomer coupling insert. Align the key ways 180 degrees apart. Set the coupling gap to the manufactures recommended distance for the coupling being installed. Properly lubricate the coupling if applicable.
